CVUSD – THOUSAND OAKS CLUSTER SURVEY

Waverly (Conejo Valley Adult School) | *Survey*

1025 Old Farm Road | Thousand Oaks, CA 91360

December 9th, 2016

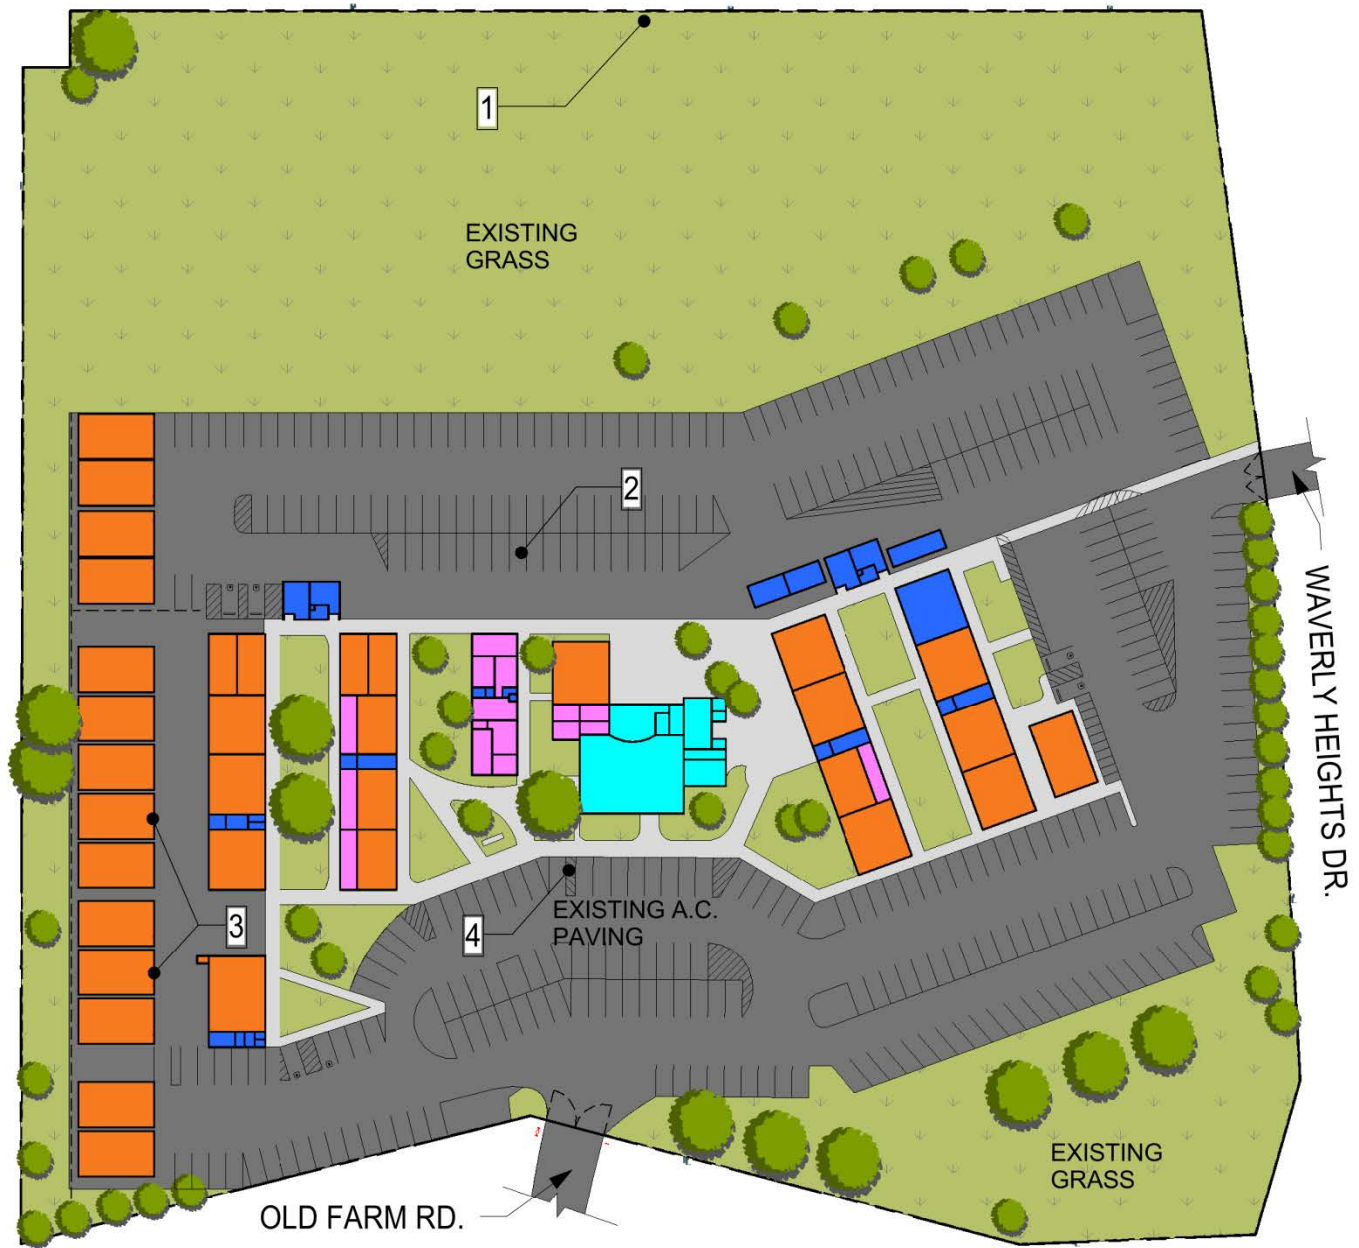
EXISTING SITE PLAN | WAVERLY ELEMENTARY SCHOOL BUILDING USE

- 1 CAMPUS IS OPEN TO NEIGHBORING PARK AND LACKS SECURITY.
- 2 REAR PARKING LOT DOES NOT HAVE LIGHTING.
- 3 MANY PORTABLES ARE DO NOT MEET ACCESSIBILITY REQUIREMENTS.
- 4 INSUFFICIENT ACCESSIBLE STALLS AND LACK OF ACCESSIBLE PATH OF TRAVEL.

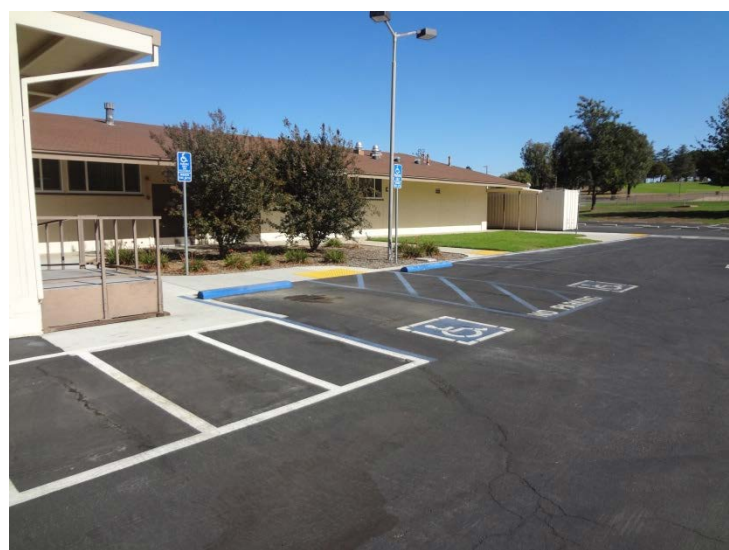
Photo -1
Building Number: 12
 Accessible parking stall and detectable warning pavers.

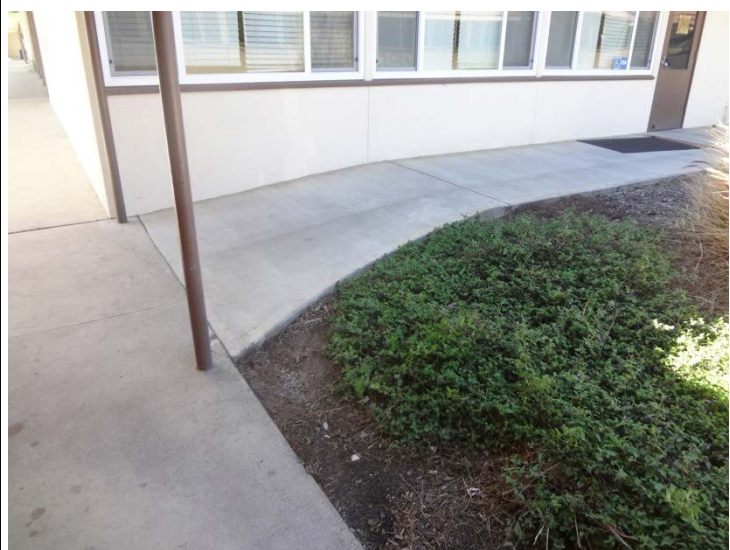
Photo -2
Building Number: 2
 Non-compliant excessive slope condition at walkway.

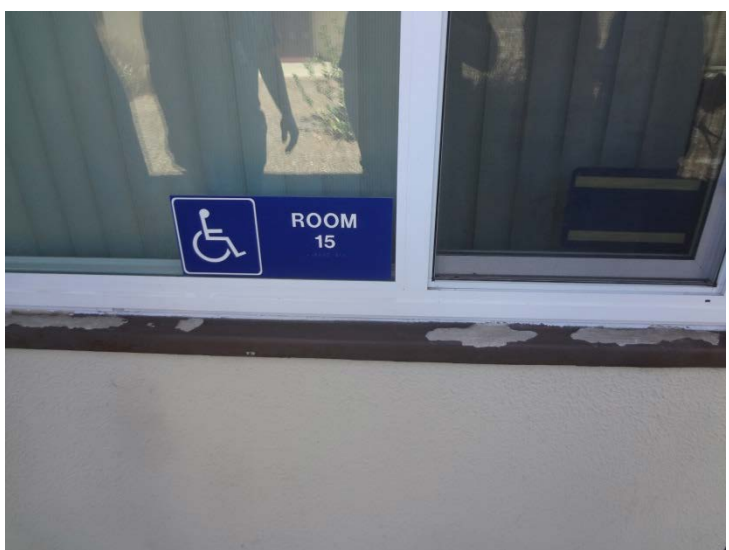
Photo -3
Building Number: 12
 Accessibility signage at non compliant classrooms throughout campus.

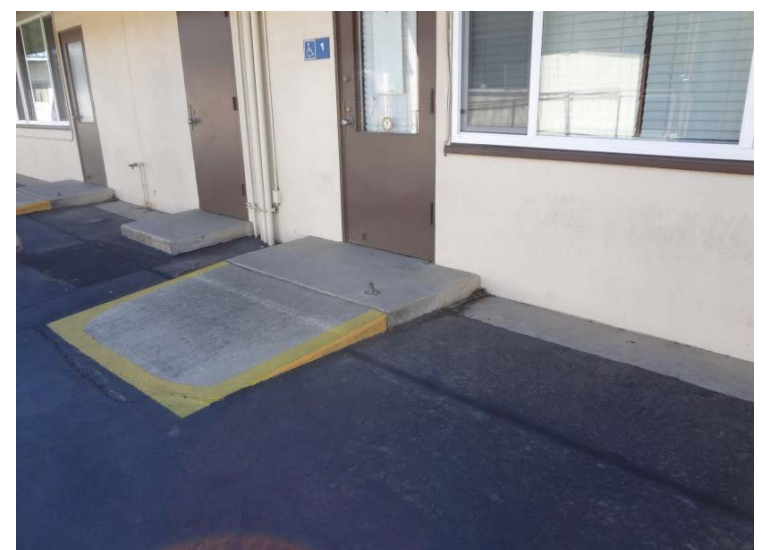
Photo -4
Building Number: 4
 Existing landings are inaccessible throughout Building 4.

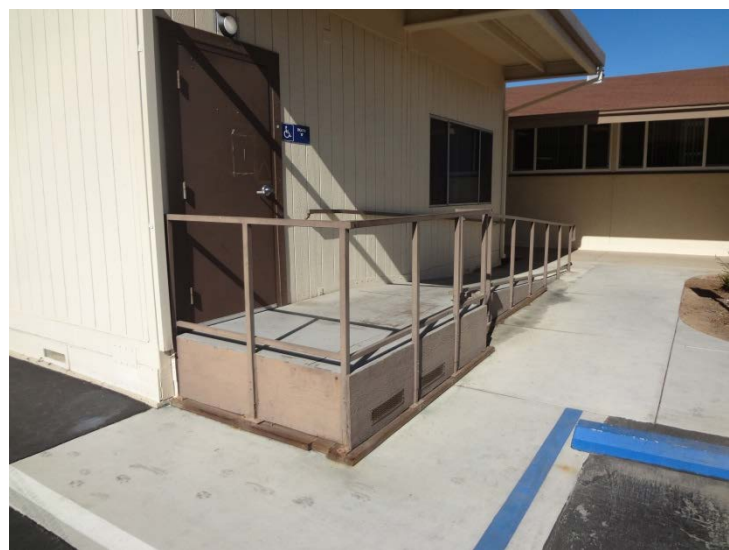
Photo -5
Building Number: 13
 Ramp up to Building 13.

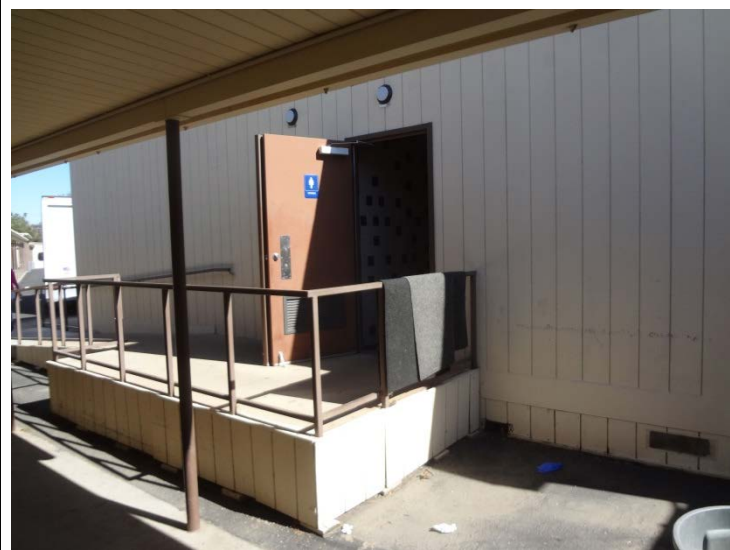
Photo -6
Building Number: 14
 Ramp at portable restroom Building 14.

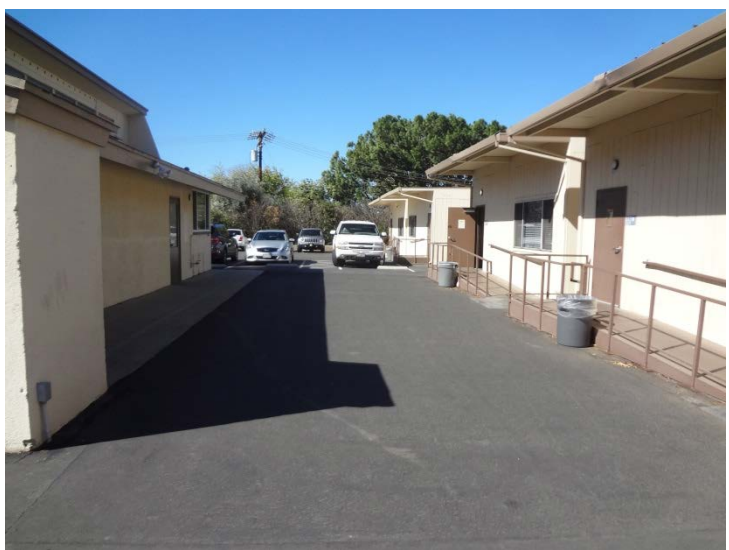
Photo -7
Building Number: 7, 14
 Area between Building 7 and the portables comprising Building 14.

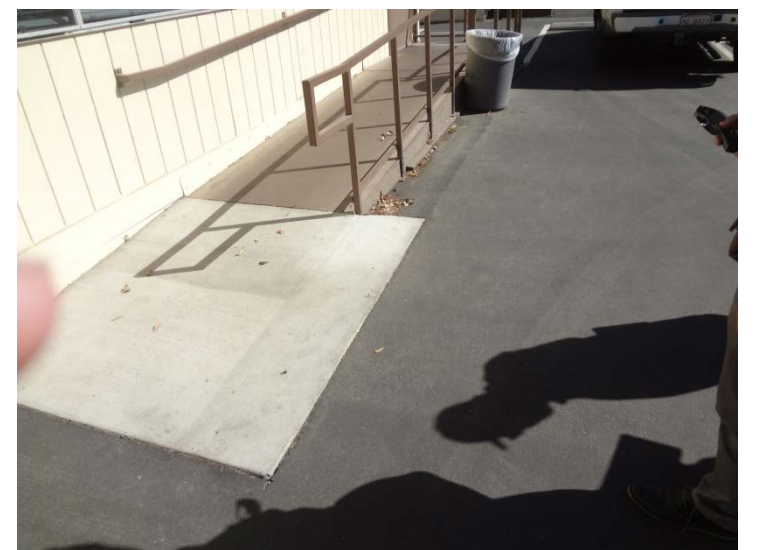
Photo -8
Building Number: 5
 Typical ramp at portables with inaccessible handrails.

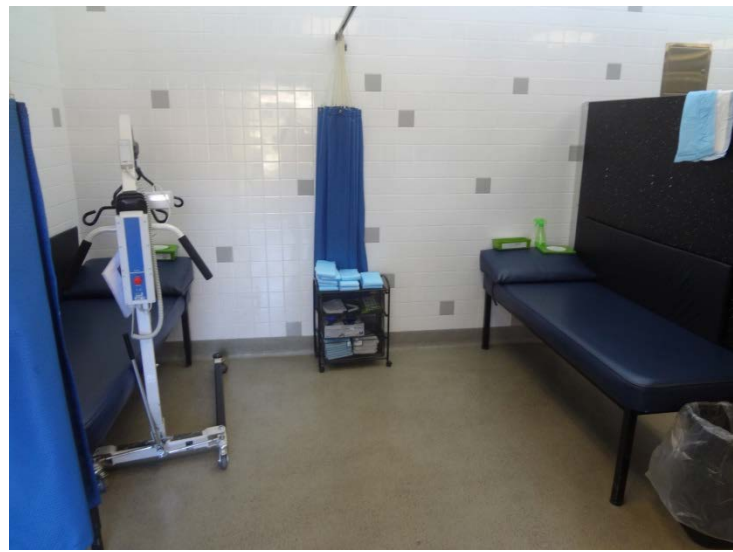
Photo -9
Building Number: 12
Cerebral Palsy equipment in the restroom at Building 12.

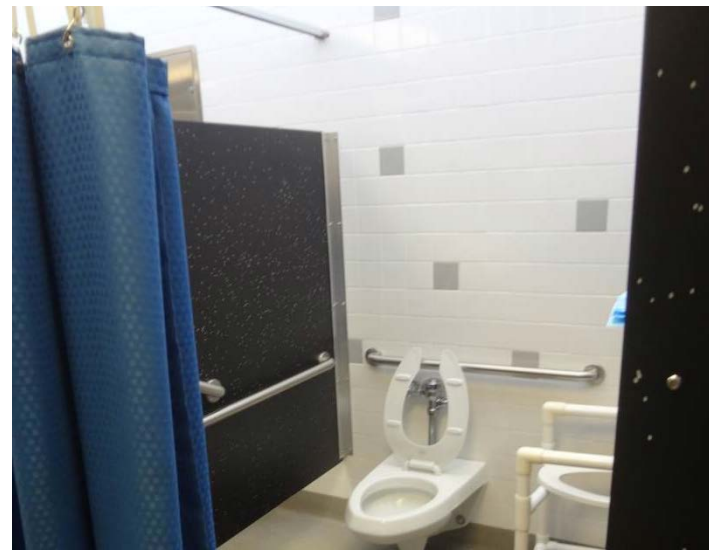
Photo -10
Building Number: 12
Special restroom stall for Cerebral Palsy program.

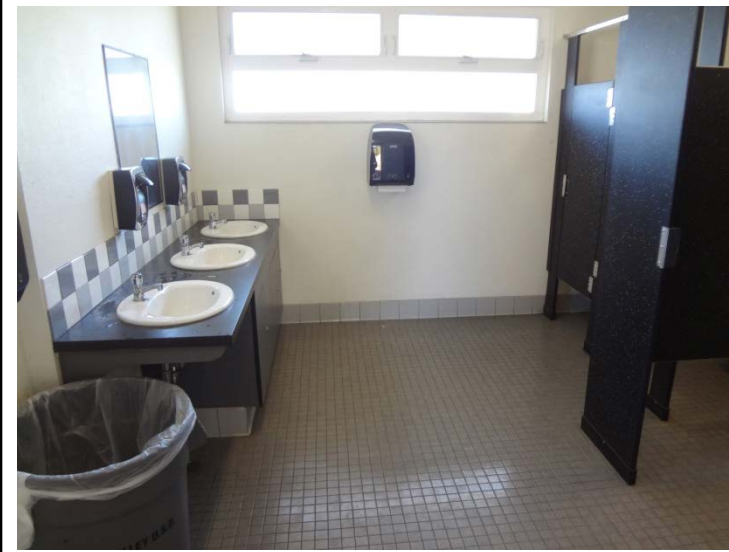
Photo -11
Building Number: 3
Compliant sink within restroom.

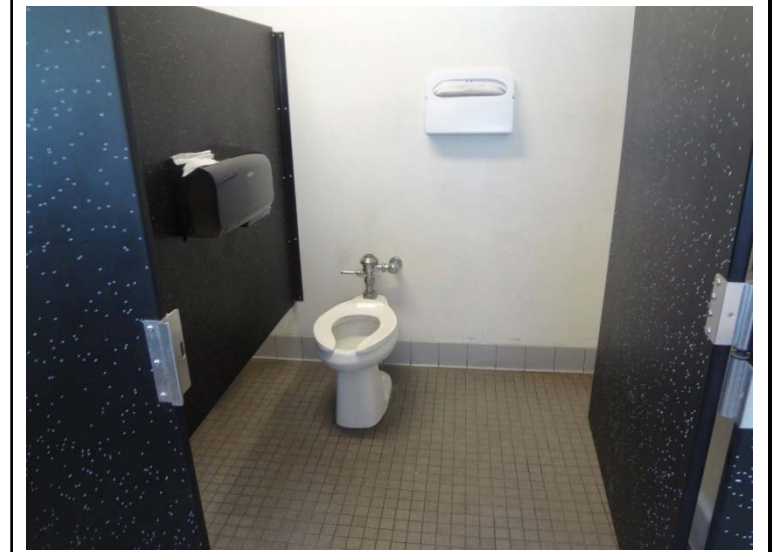
Photo -12
Building Number: 3
Accessible stall within building 3 requiring handrail.

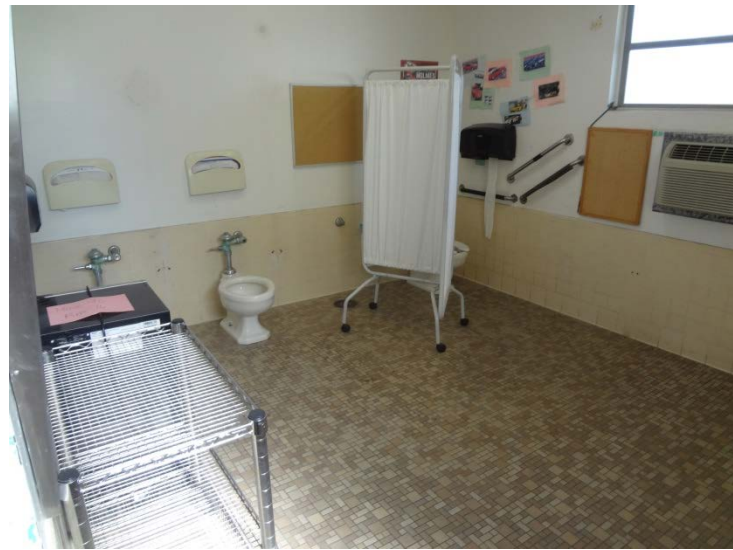
Photo -13
Building Number: 11
Special needs restroom.

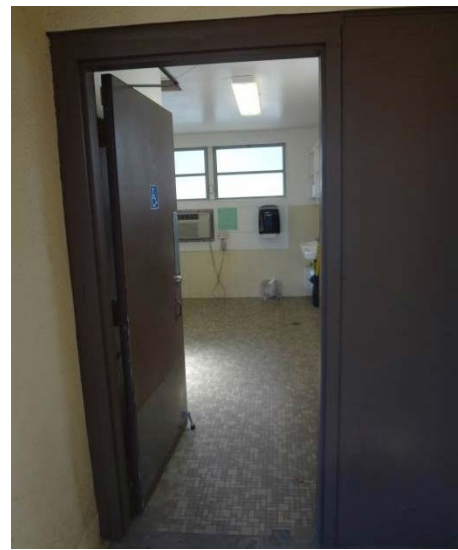
Photo -14
Building Number: 11
Narrow door threshold at Building 11.

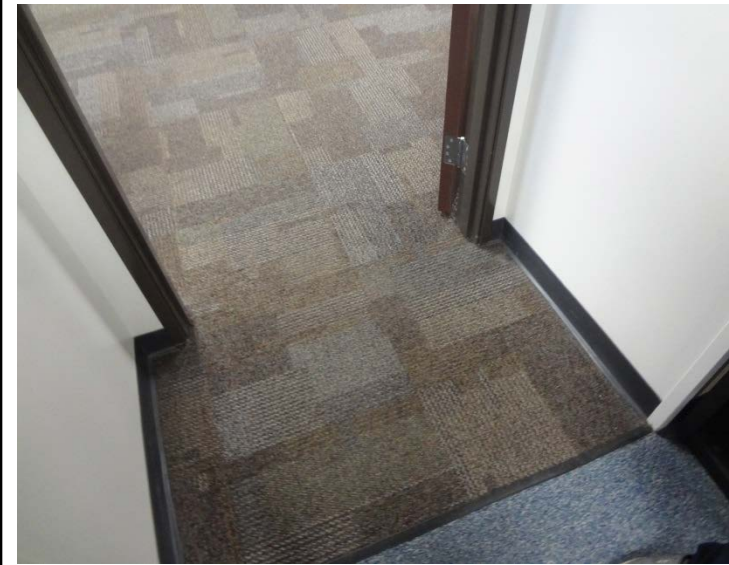
Photo -15
Building Number: 5
Carpet condition within portable Building 5

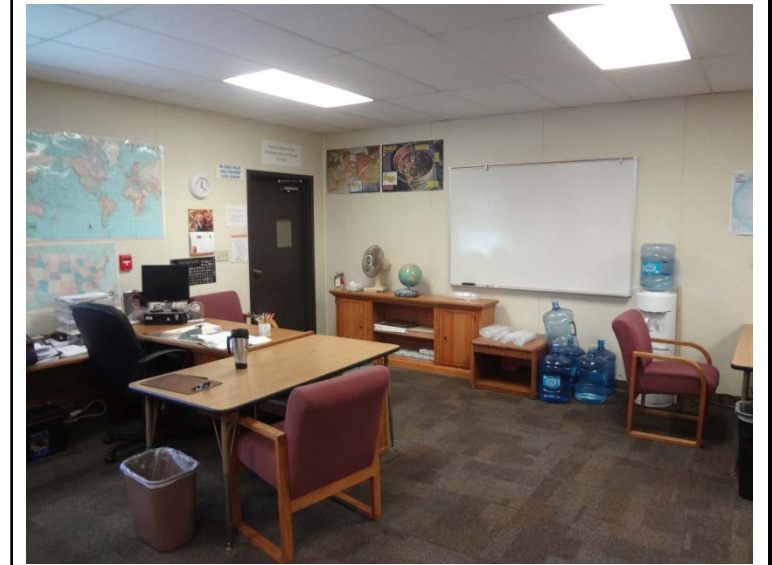
Photo -16
Building Number: 5
General condition of the Building 5 office.

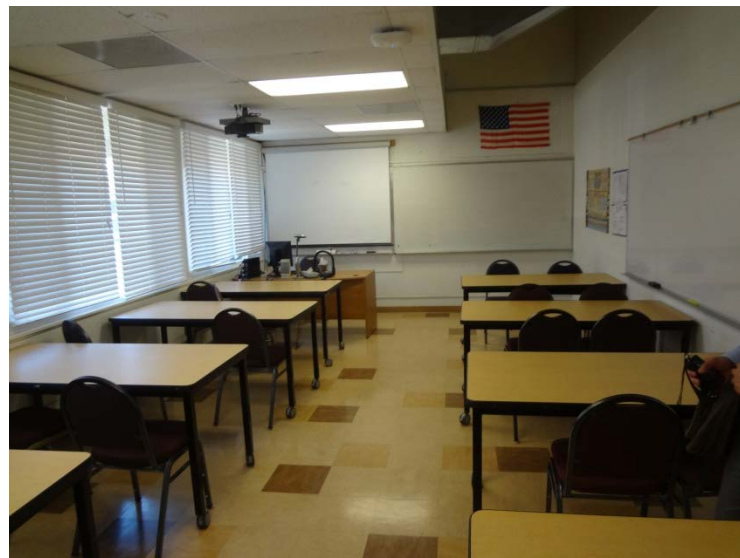
Photo -17
Building Number: 4
General split classroom condition within Building 4.

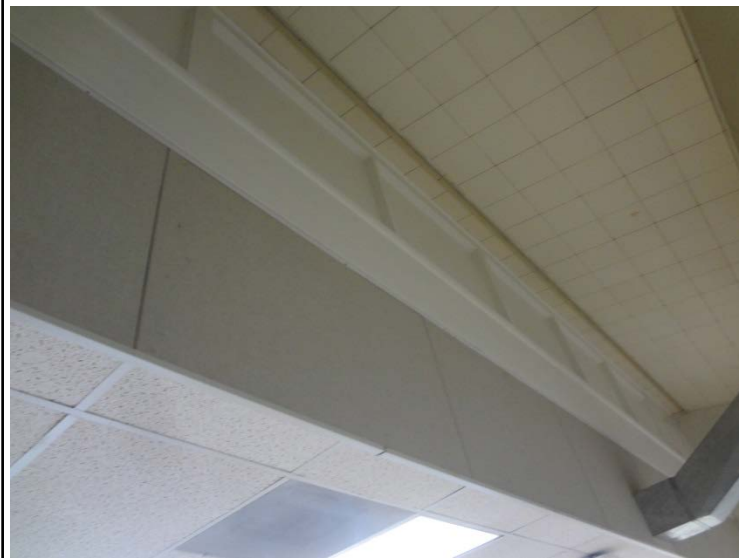
Photo -18
Building Number: 4
Ceiling condition within split classroom.

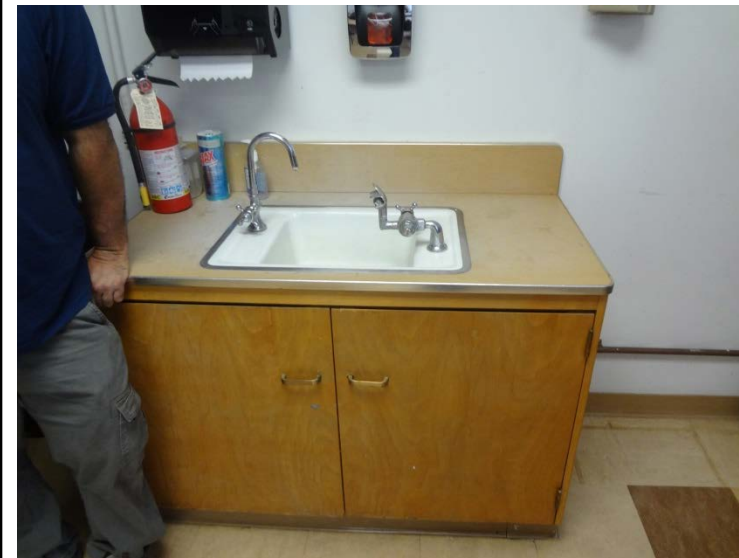
Photo -19
Building Number: 2
Example image of non compliant sinks throughout campus.

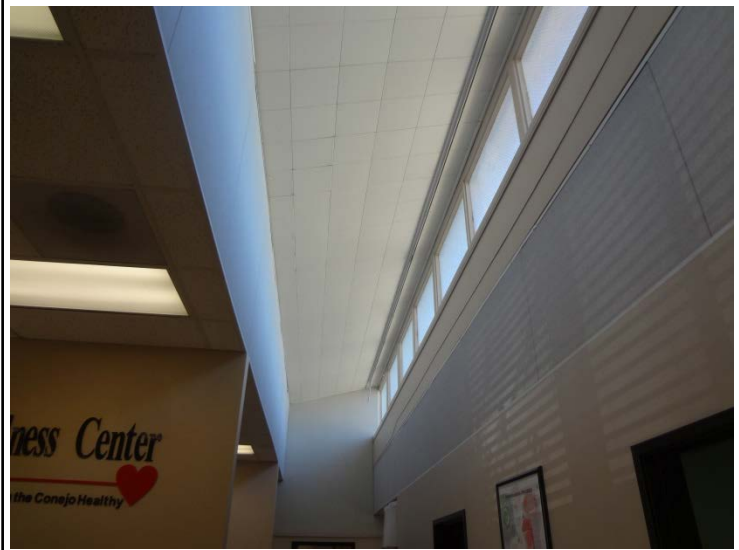
Photo -22
Building Number: 7
Ceiling condition and clerestory windows of medical training classrooms.

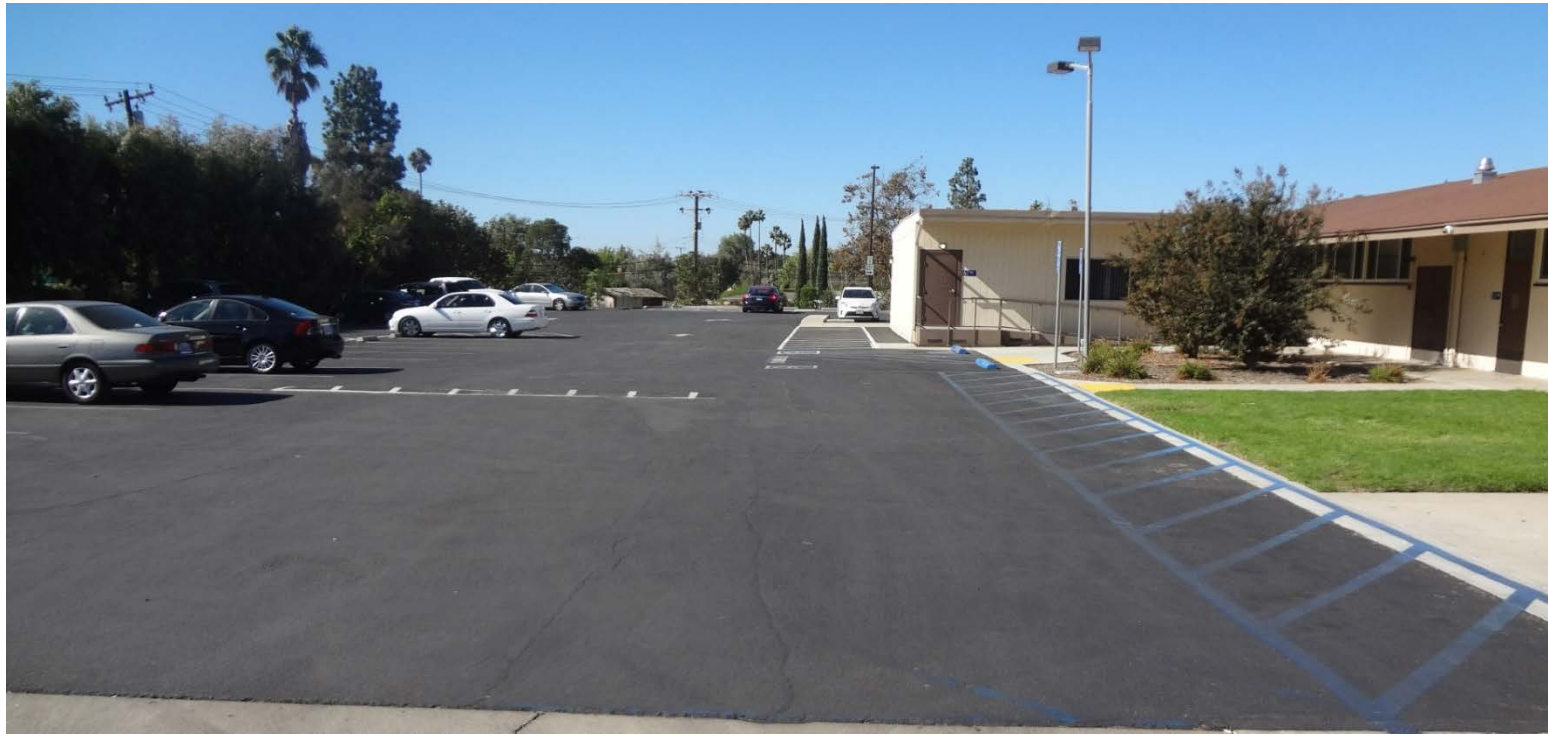
Image 1: School has no primary circulation point. Parking lot surrounds school and site can be access from any point in parking.

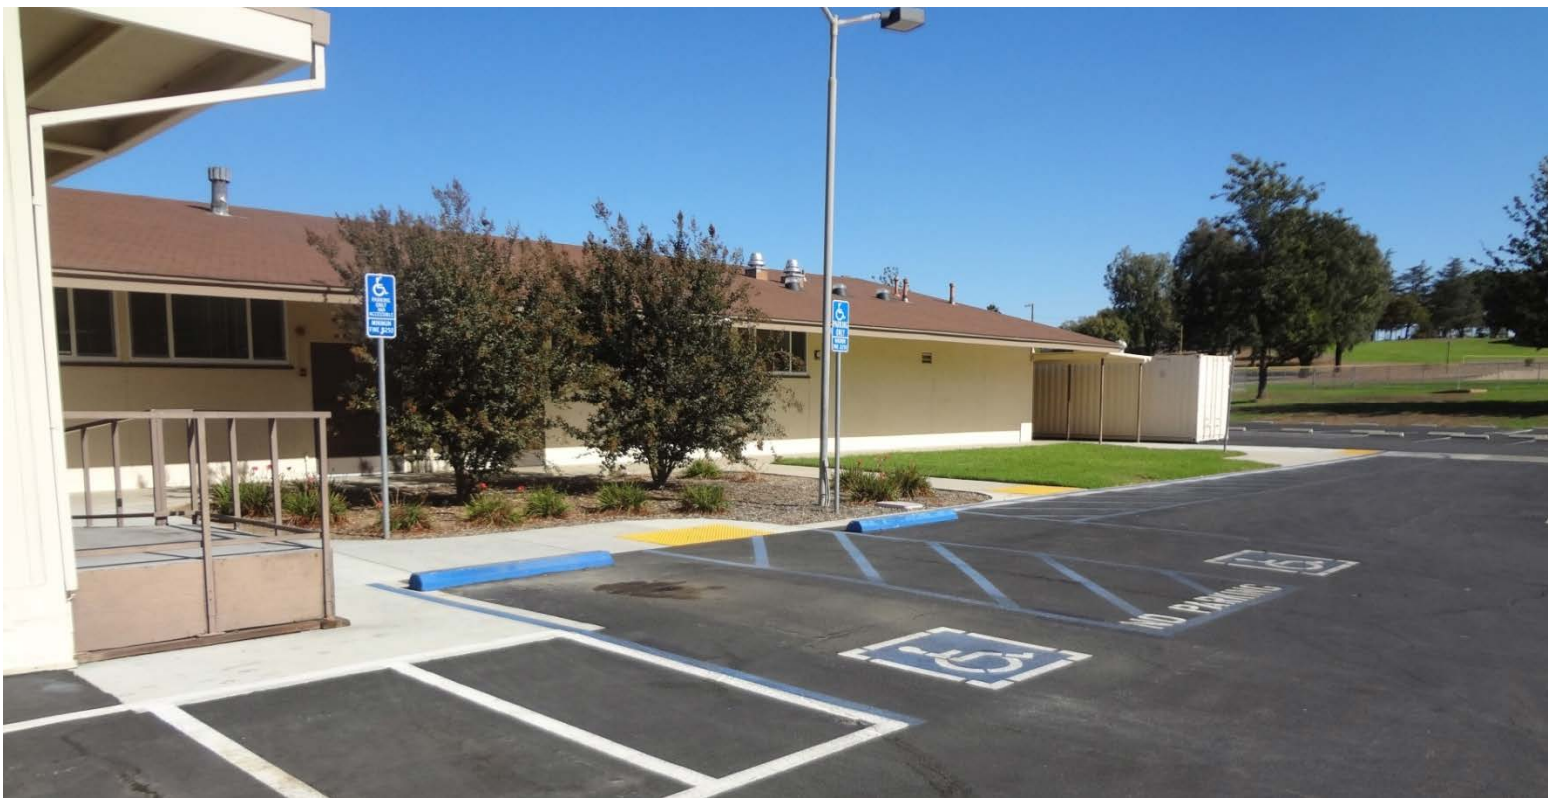
Image 2: School has no primary circulation point. Parking lot surrounds school and site can be access from any point in parking.

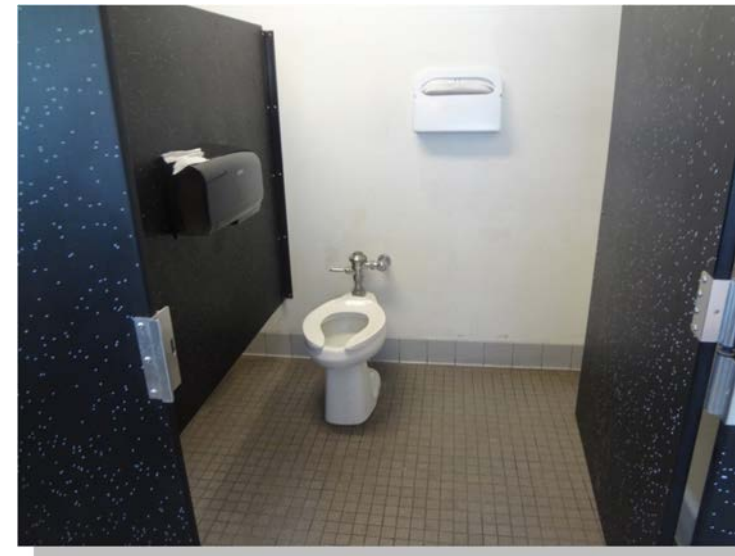
Photo -1
Many of the bathrooms have been upgraded but they were not done so in complete compliance with accessibility standards

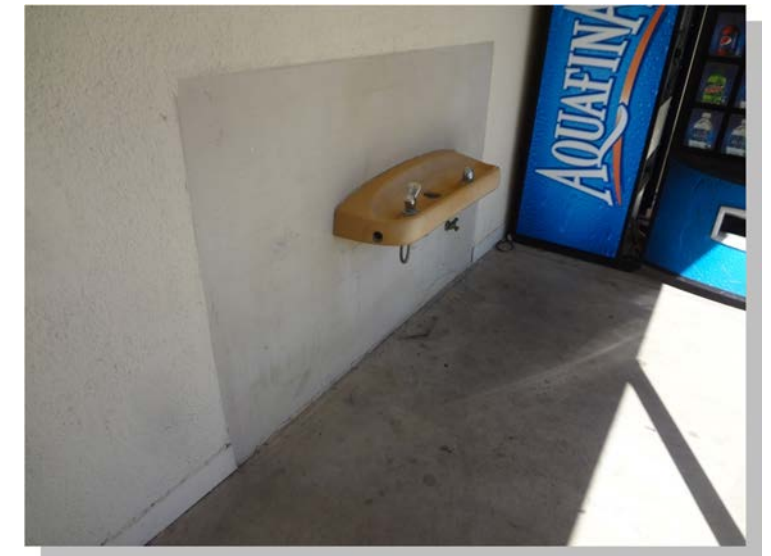
Photo -2
The drinking fountains have not been updated to current accessibility standards

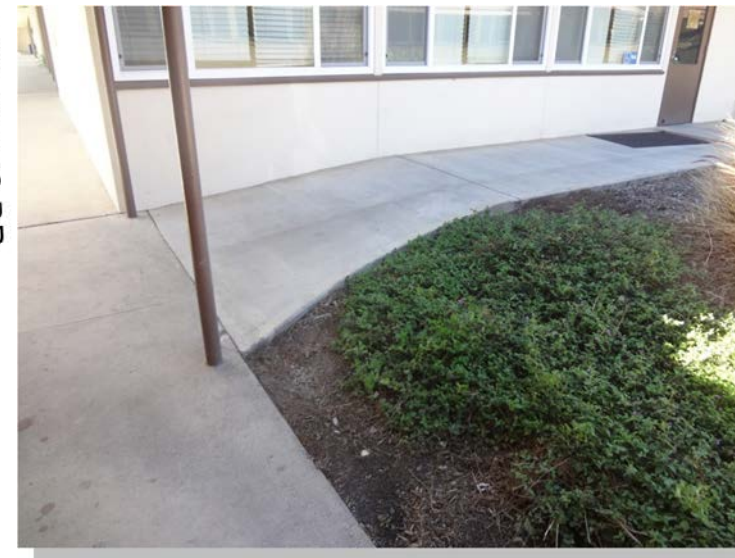
Photo -4
There are site accessibility issues all over campus that will need to be addressed when the school is modernized

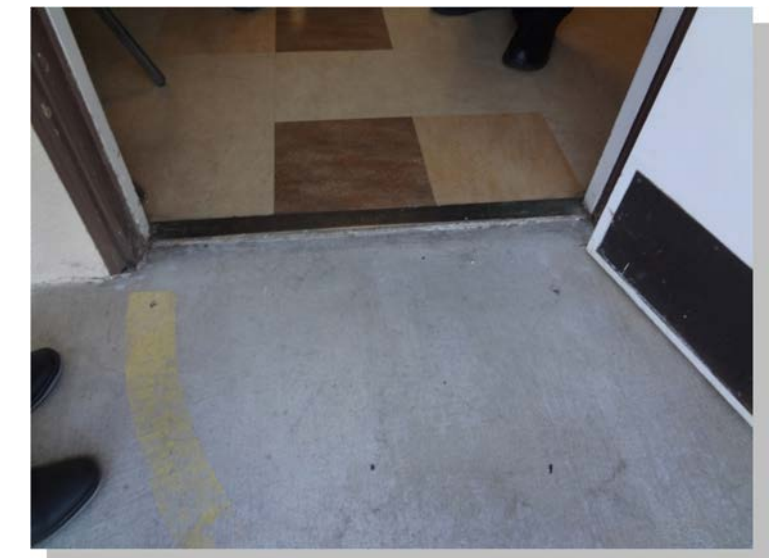
Photo -4
None of the thresholds have been updated to current accessibility standards.
