**WILDWOOD**

Elementary School

## Wildwood Elementary School | *Site Analysis*

January 10th, 2017

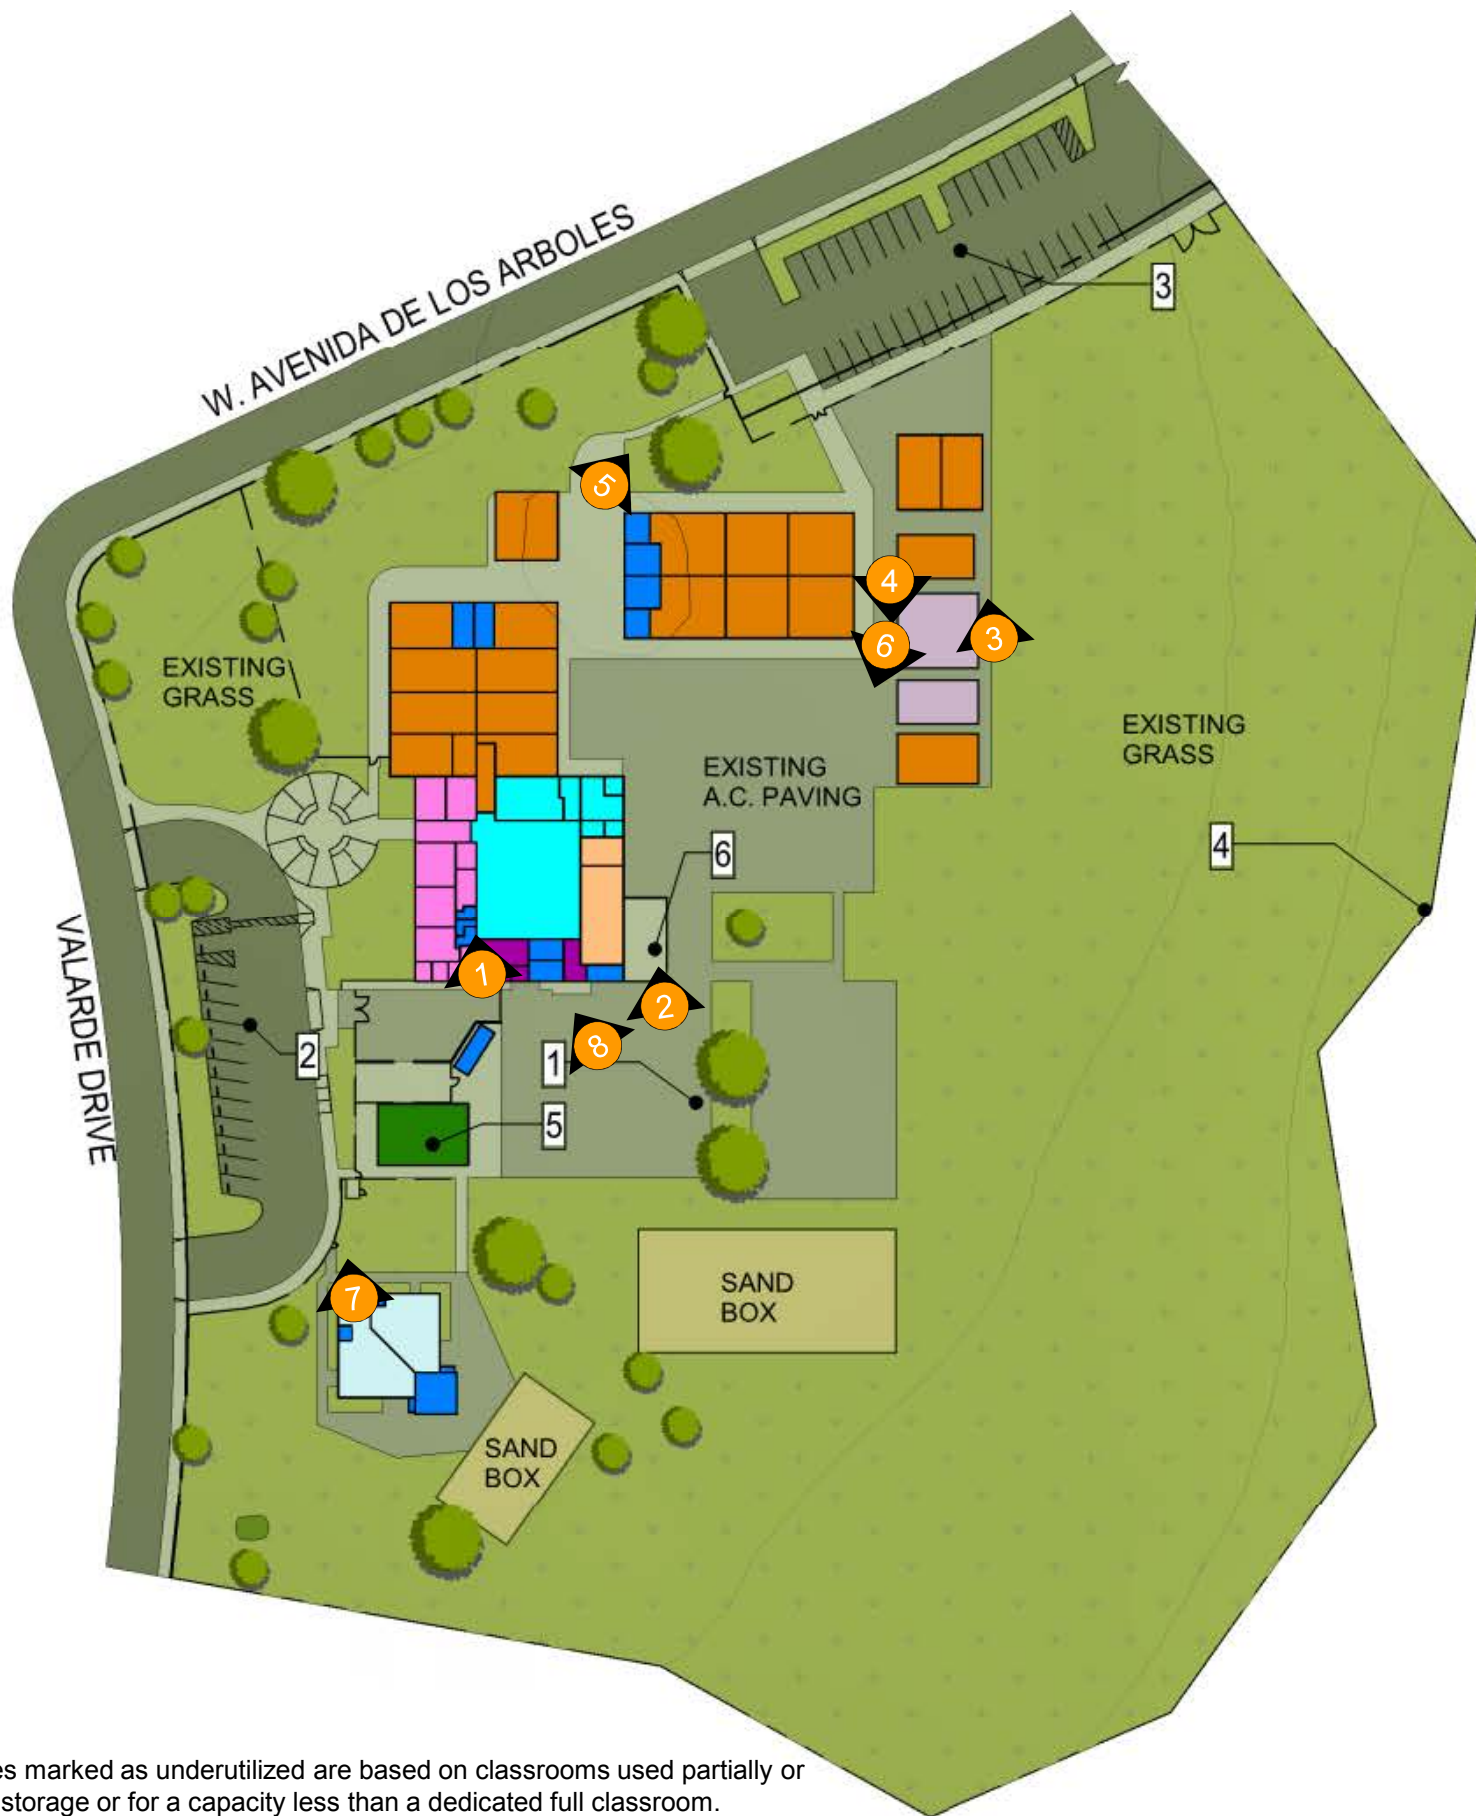
**EXISTING SITE PLAN | WILDWOOD ELEMENTARY SCHOOL BUILDING USE**

- 1 POSSIBLE SHADE STRUCTURE LOCATION
- 2 FRONT PARKING LOT IS FULLY UTILIZED AND MAY BECOME JAMMED DURING PICK UP AND DROP OFF.
- 3 BACK LOT BELONGS TO PARKS AND RECREATION, SOME PARENTS USE THE LOT FOR DROP-OFF.
- 4 GATE IS NOT FULLY SECURED
- 5 LUNCH SHELTER MAY NEED OF REPAINTING.
- 6 OUTDOOR SEATING SPACE WITH TALL CMU WALLS AROUND AND NO WHEEL CHAIR ACCESSIBLE PATH TO THE BUILDING

- ACCESSIBILITY UPGRADES NEEDED AT RAMPS, THRESHOLDS, AND LANDINGS THROUGHOUT CAMPUS.
- CARPETING UPGRADES NEEDED THROUGHOUT CAMPUS.
- ACCESSIBILITY UPGRADES AT PORTABLES NEEDED. SOME PORTABLES ARE ALSO DETERIORATED AND ARE IN NEED OF REPLACEMENT.
- INCREASING ENROLLMENT PUTTING STRAIN ON EXISTING CLASSROOMS. MORE SPACE NEEDED.
- SOME ACCESSIBILITY UPGRADES NEEDED IN SOME RESTROOMS AND AT SOME SINKS TO BECOME COMPLIANT.
- ELECTRICAL SURVEY NEEDED. INCREASED USAGE LOAD IS MORE THAN ORIGINAL WIRING CAN HANDLE SUFFICIENTLY.

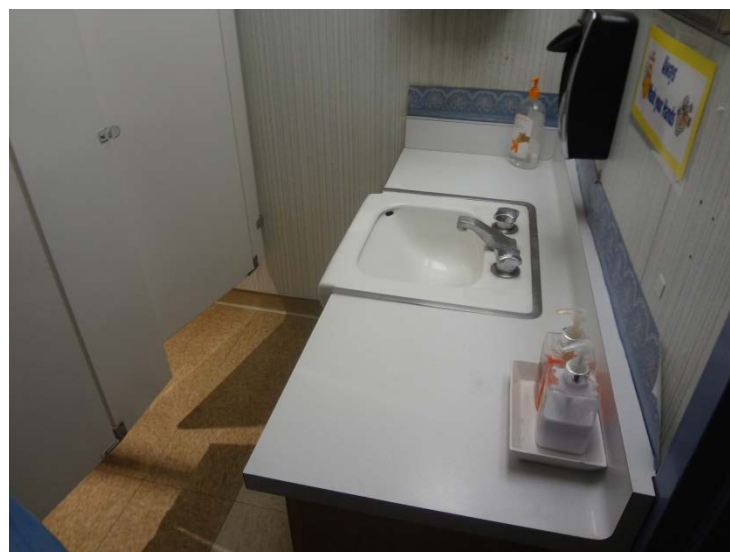
**Photo -1**  
**Accessibility Issues**  
 Campus wide accessibility upgrades may be needed to bring the campus in full compliance with accessibility standards.

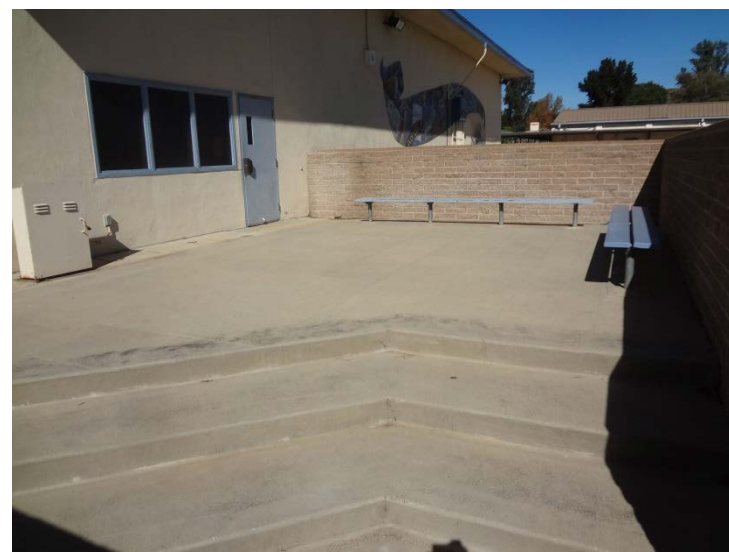
**Photo -2**  
**Sitting Area Behind MPR**  
 Sitting area behind MPR appears to have no clear purpose and is not wheelchair accessible.

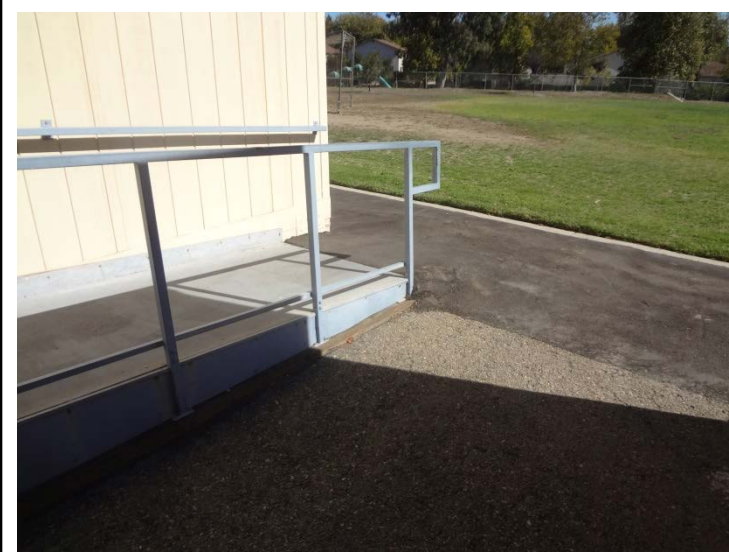
**Photo -3**  
**Accessibility Issues**  
 Campus wide accessibility upgrades may be needed to bring the campus in full compliance with accessibility standards.

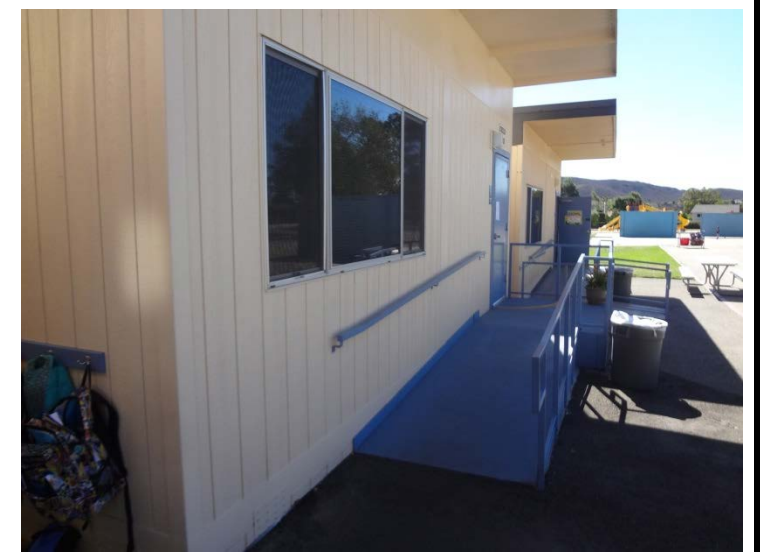
**Photo -4**  
**Numerous Portables**  
 There are numerous portable buildings, several of which are not DSA certified.

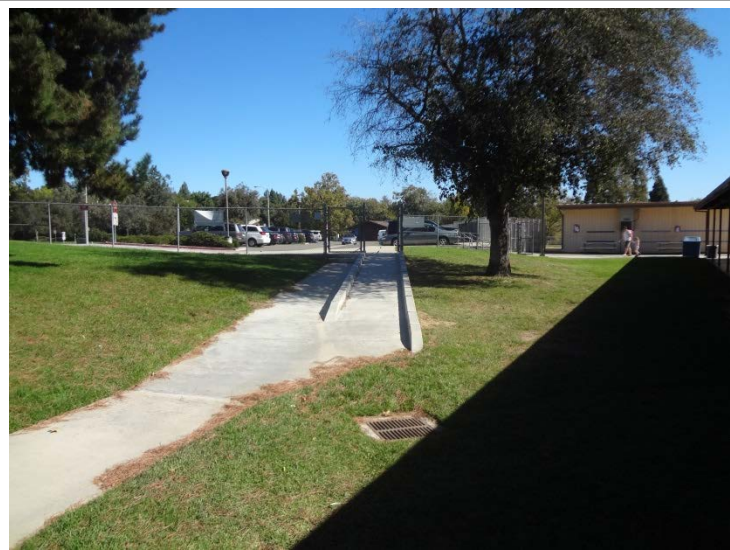
**Photo -5**  
**Secondary Entry To Campus**  
 The secondary entry to campus has wheelchair accessibility issues.

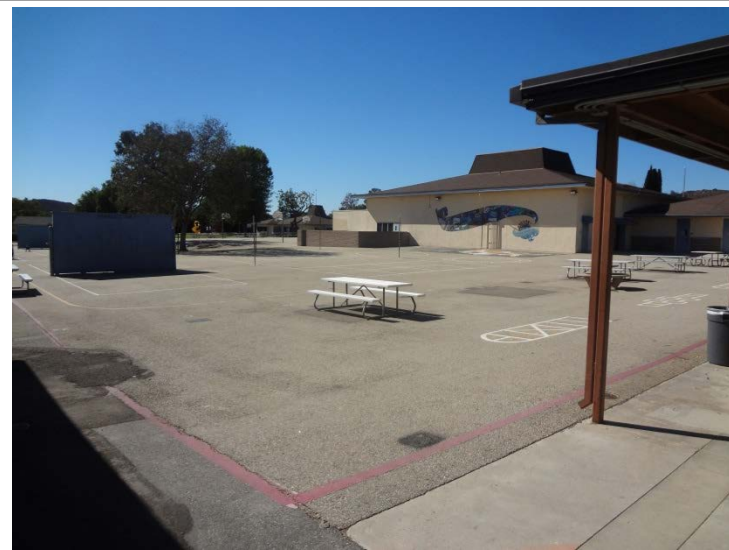
**Photo -6**  
**Lack of Shading**  
 The campus has large amounts of black top area with little shading from trees or buildings.

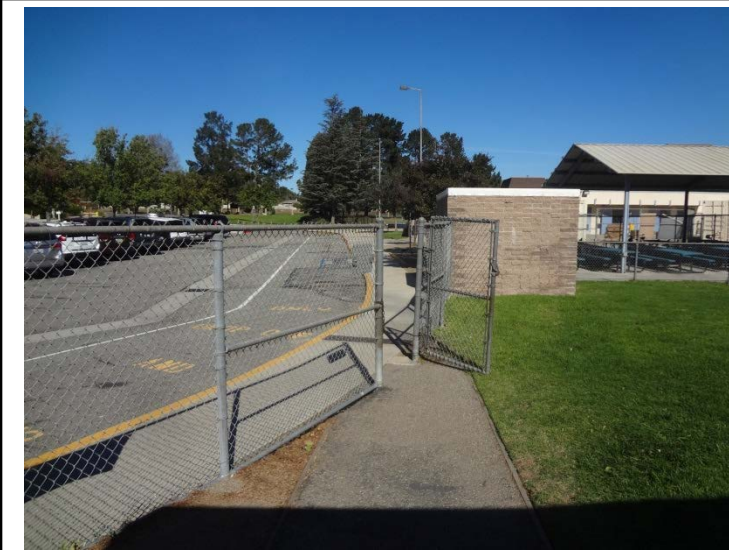
**Photo -7**  
**Kindergarten Entry**  
 The kindergarten entry to campus may have accessibility issues related to hardware and wheelchair clearances.

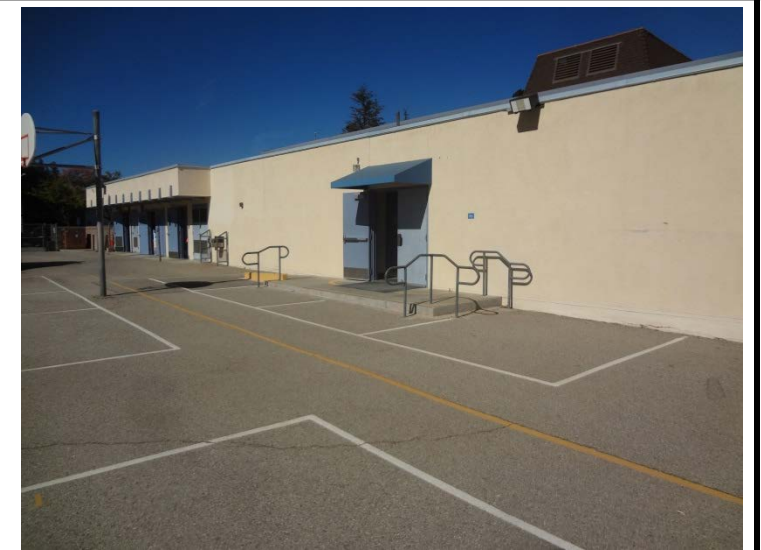
**Photo -8**  
**Back of MPR**  
 The backside of the MPR has accessibility issues as well as a lack of shading.

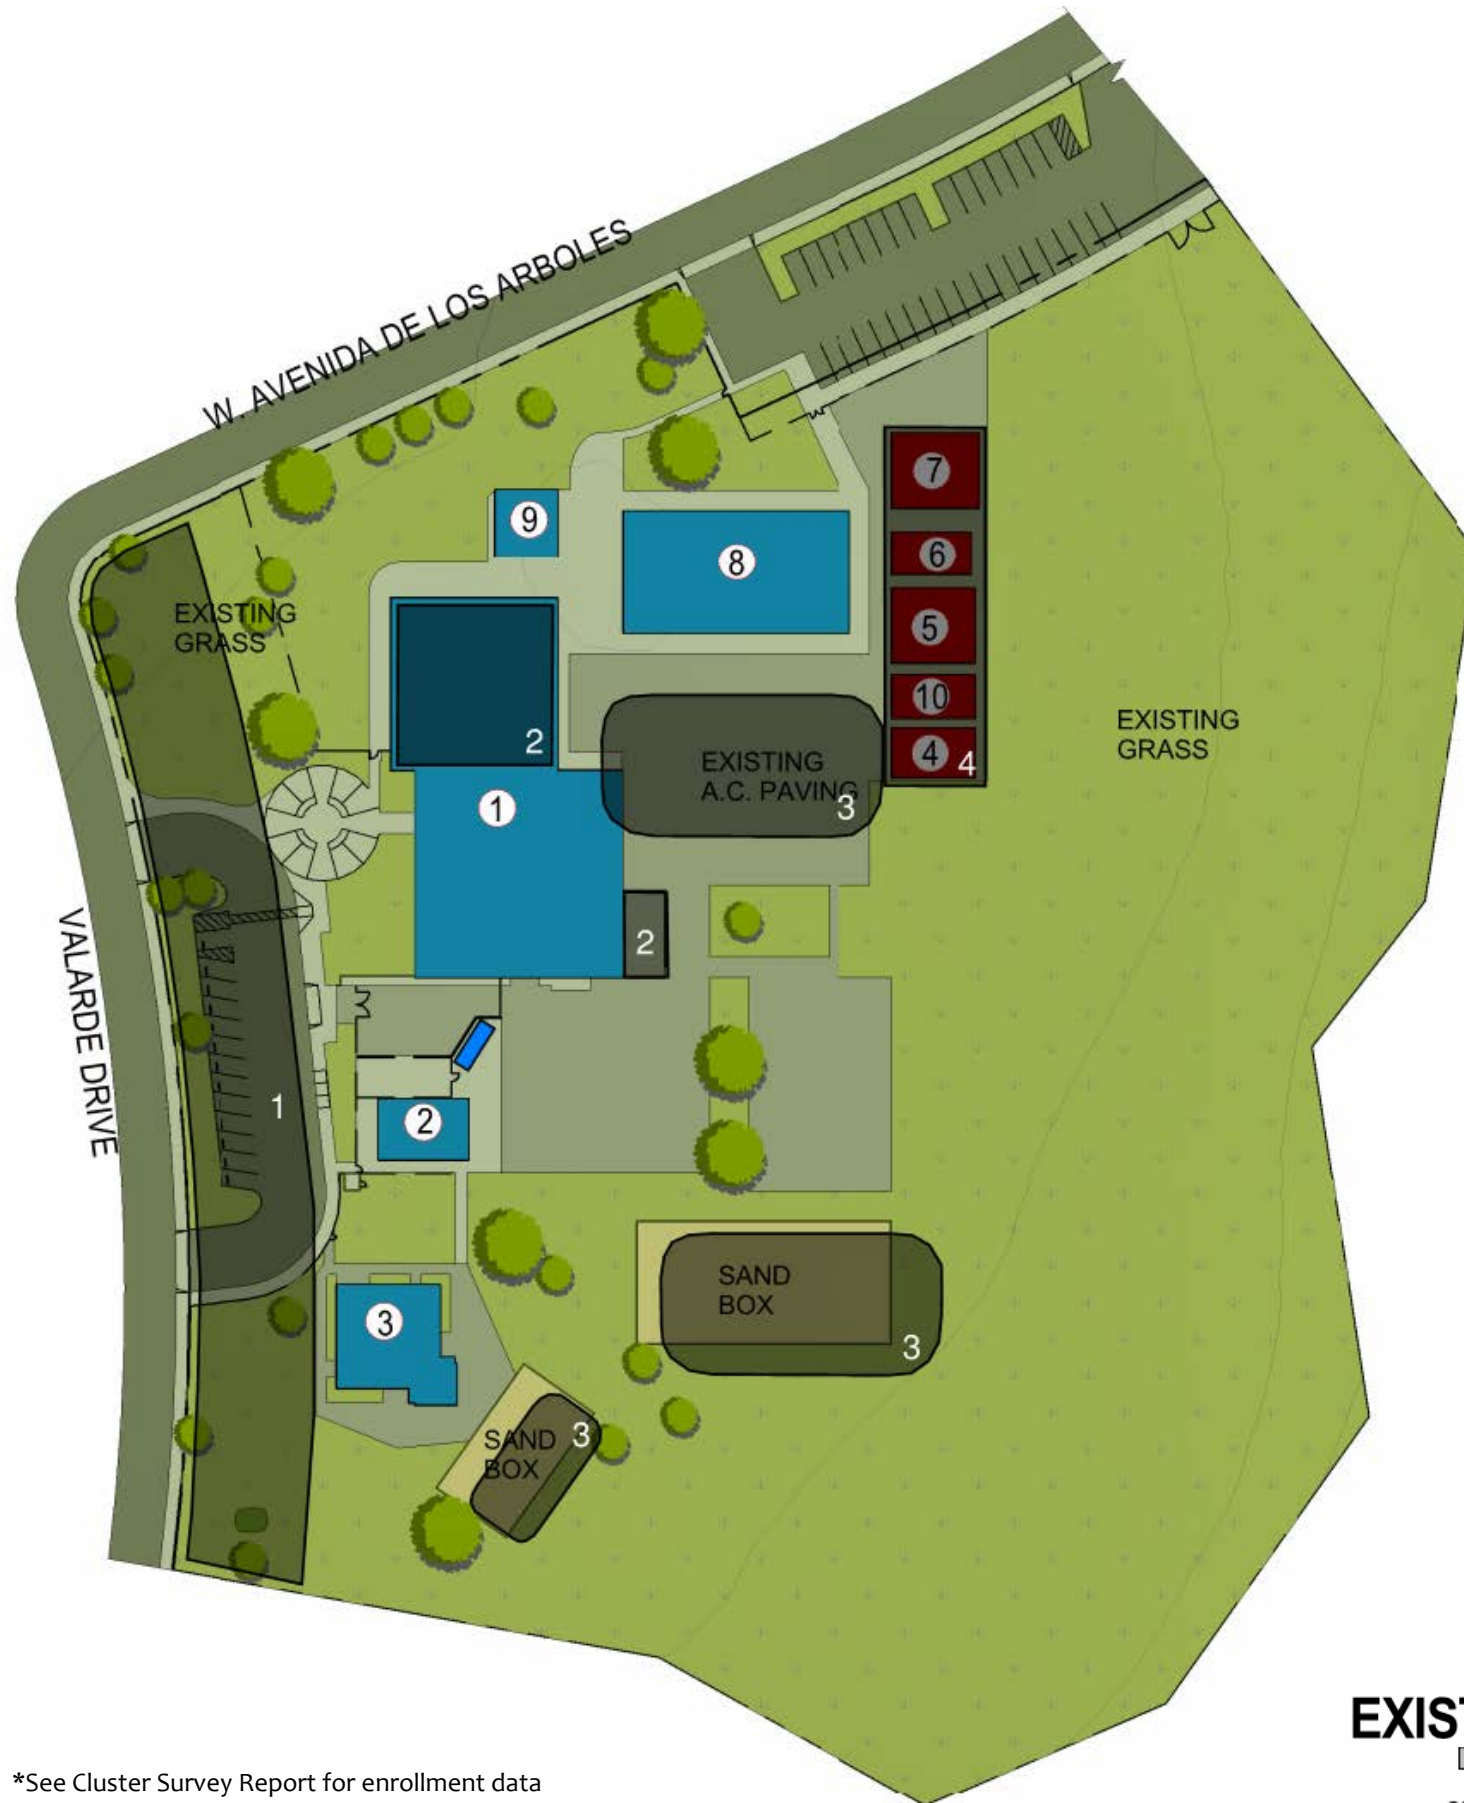
### EXISTING SITE PLAN | WILDWOOD ELEMENTARY SCHOOL PERMANENT AND PORTABLE

Area 1: The parking lot and drop-off area in front of the school main entrance have insufficient capacity for loading as well as parking for the visitors. To increase the capacity, further study and design alternatives may arrive a solution within the north west frontage.

Area 2: The library area in the multi-purpose building may present an opportunity for a maker or flexible learning space. Improvement at the outdoor area at south corner of the building may create a more usable space for outdoor performance or activities.

Area 3: Additional shading may be added to playgrounds. Based on the solar analysis, those areas are under-protected by shade provided by either building or landscaping. Shading opportunities may be accomplished by either structure or landscaping. Play surfaces and equipment may also be upgraded as a part of the scope.

Area 4: A row of temporary classroom buildings west of the site presents an opportunity for possible replacement with a permanent building that serves music, performing art and additional flexible learning spaces.
