**WILDWOOD**

Elementary School

## Wildwood Elementary School | *Site Analysis*

January 10th, 2017

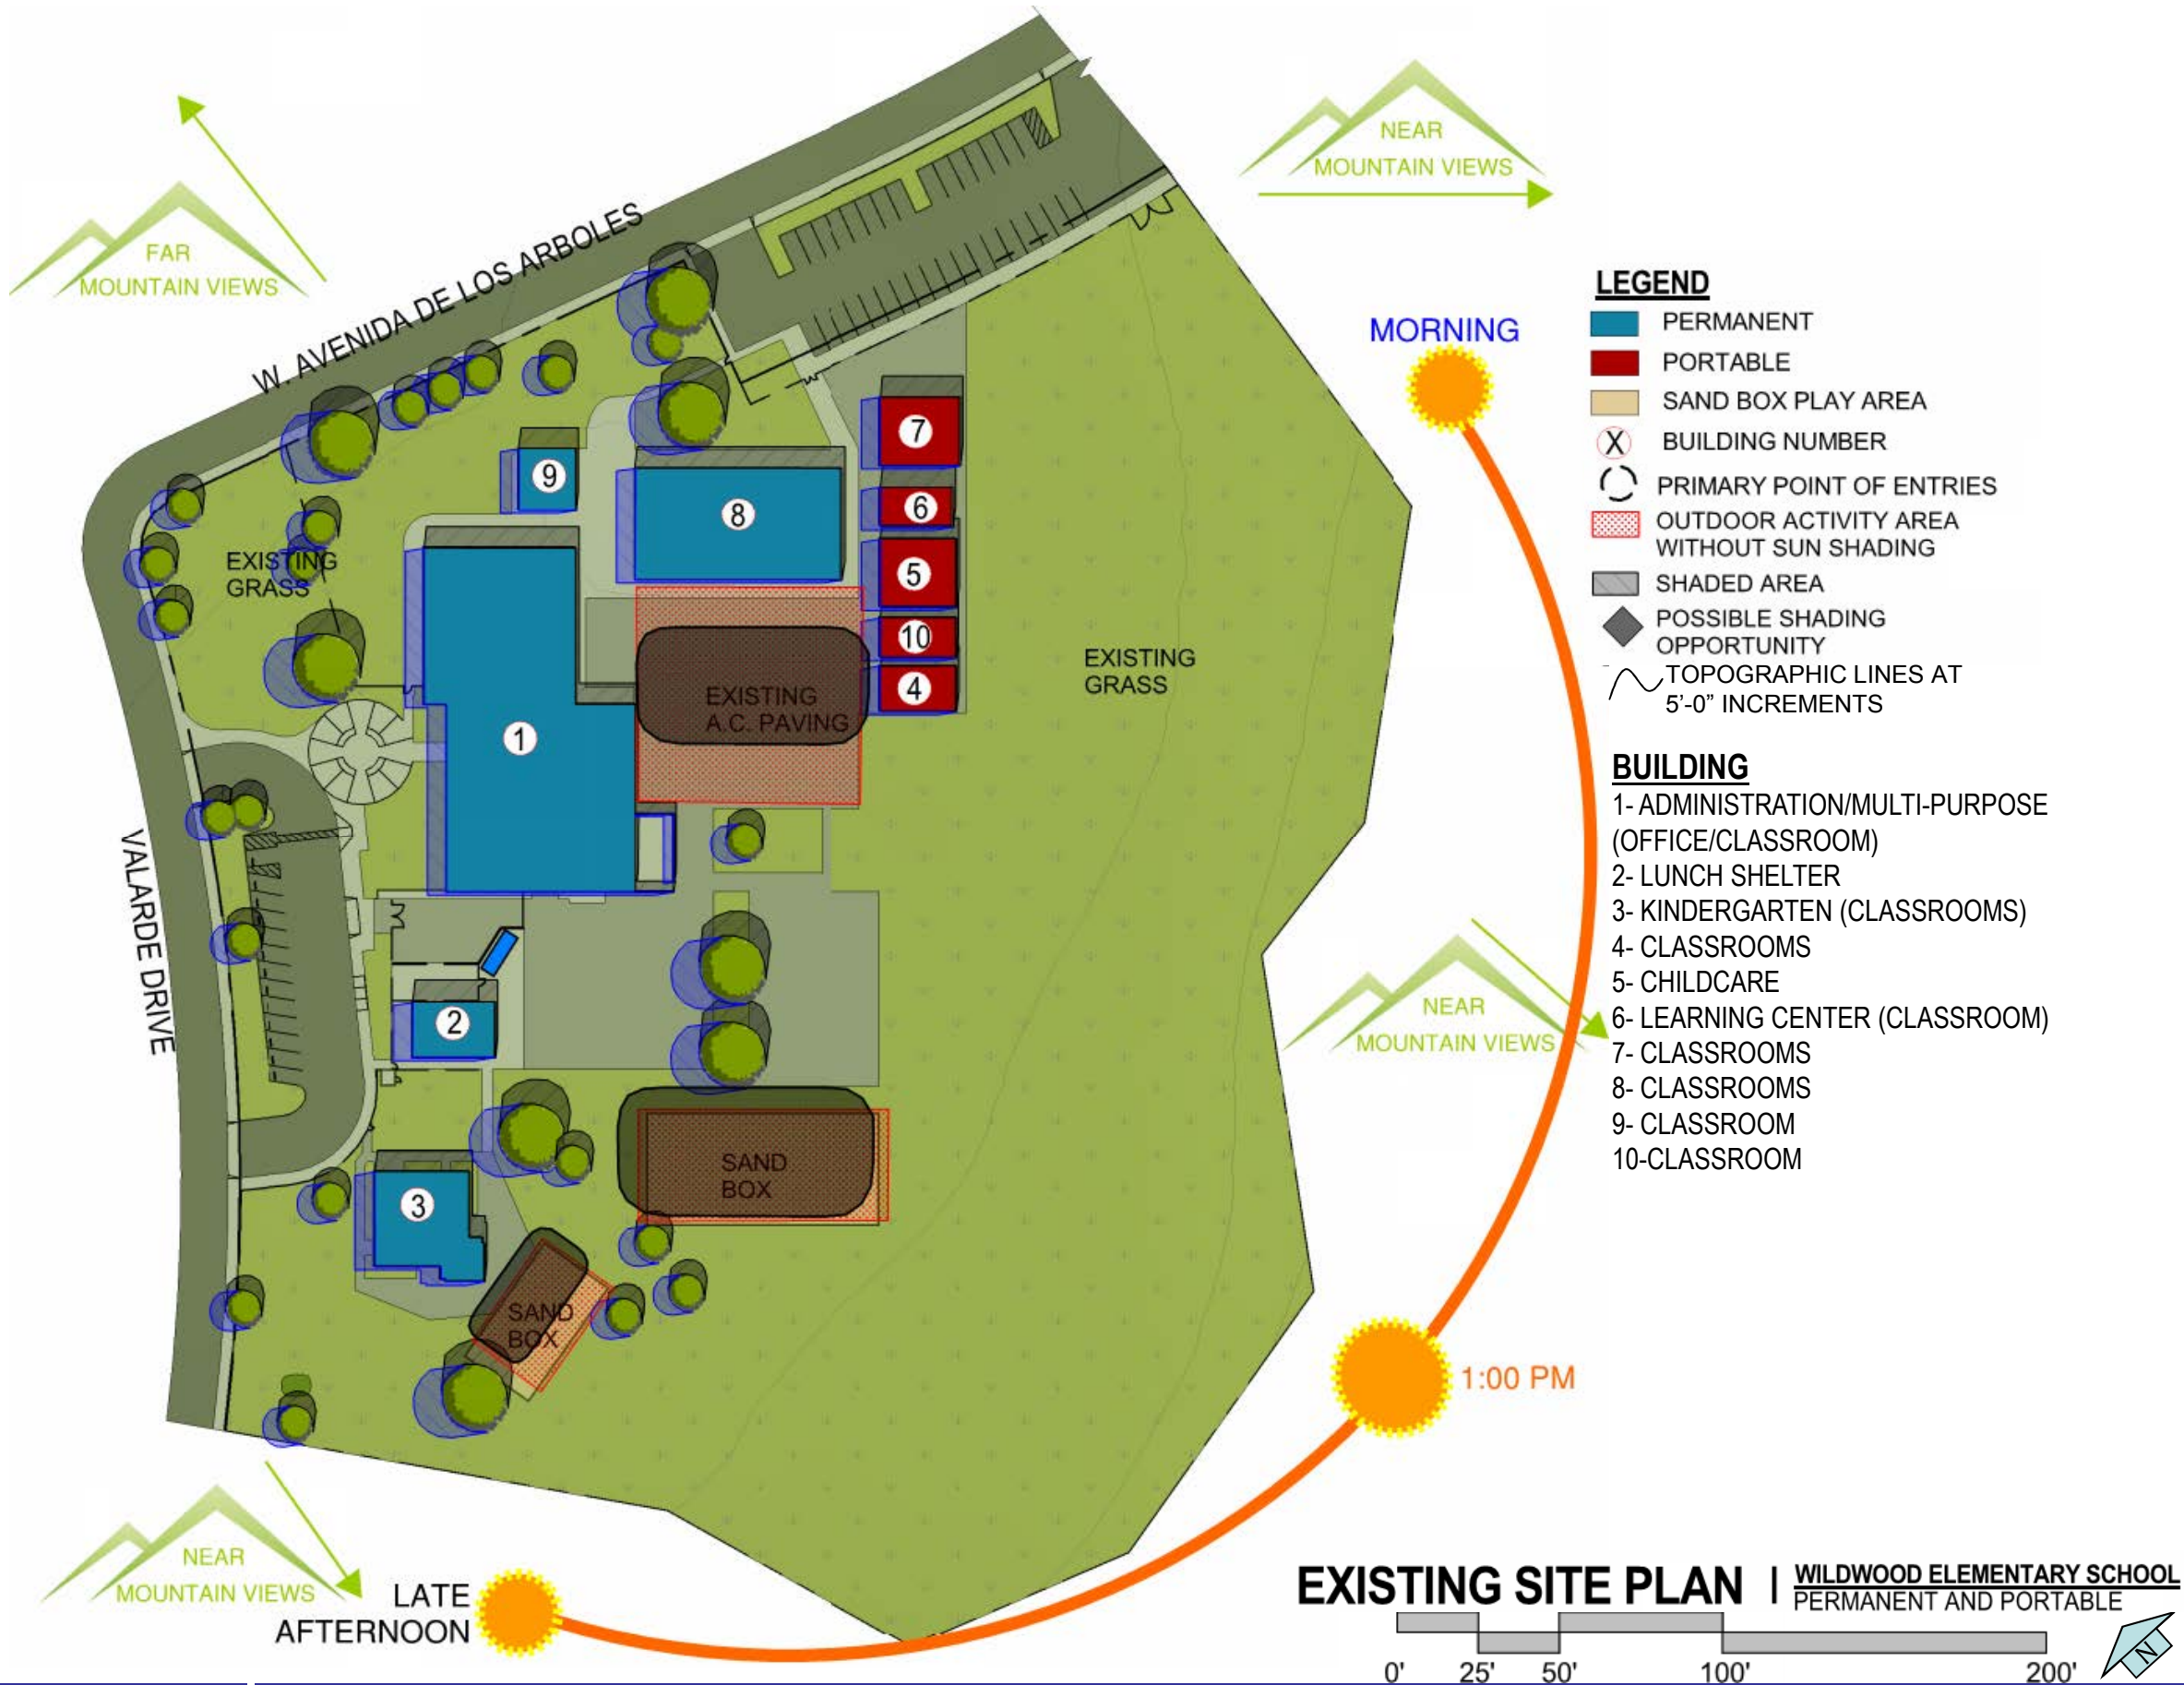
## Wildwood Elementary School Site Analysis - Environmental

Wildwood Elementary School's building alignment on the site provides little morning or afternoon shading of the playground areas. There are two possible means of providing additional shading to those outdoor activity areas.

The current building orientation, which runs in the direction from northeast to southwest, may not provide the most efficient layout for solar panels on the existing roof. Opportunity for solar power generation may not be as viable as that in other school sites.

The topography on the site is relatively flat and slopes down gradually toward south; however, the school still has several locations that require further improvement to be wheelchair accessible.

One shading opportunity is to build free-standing shading structure to shelter the playground from sun exposure. It should be noted that if free standing structure is to be built near the playground, the playground surface and equipment may be upgraded at the same time.

An alternative opportunity is to plant a row of trees at the western side of the playgrounds to provide shade in the afternoon.

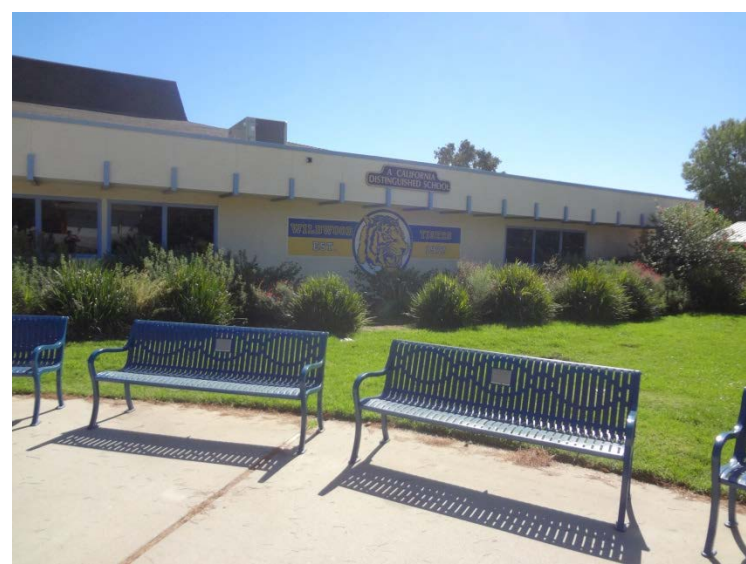
**Photo -1**  
**Curb Appeal – View at Entry of School**  
 The primary entry to the school looks directly at the administration and multi purpose building. The building has mature landscaping.

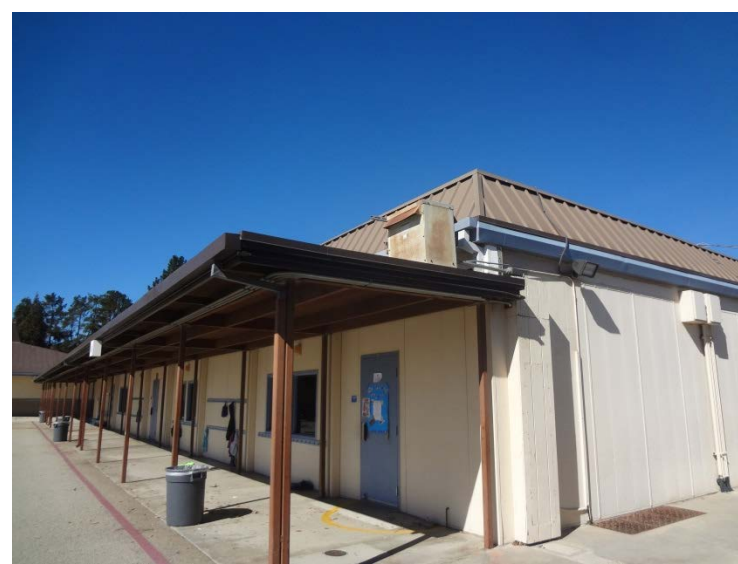
**Photo -2**  
**Curb Appeal – View of Classrooms**  
 The exterior of the classroom buildings point toward the play ground area. They have overhangs to protect the classrooms from sun and rain.

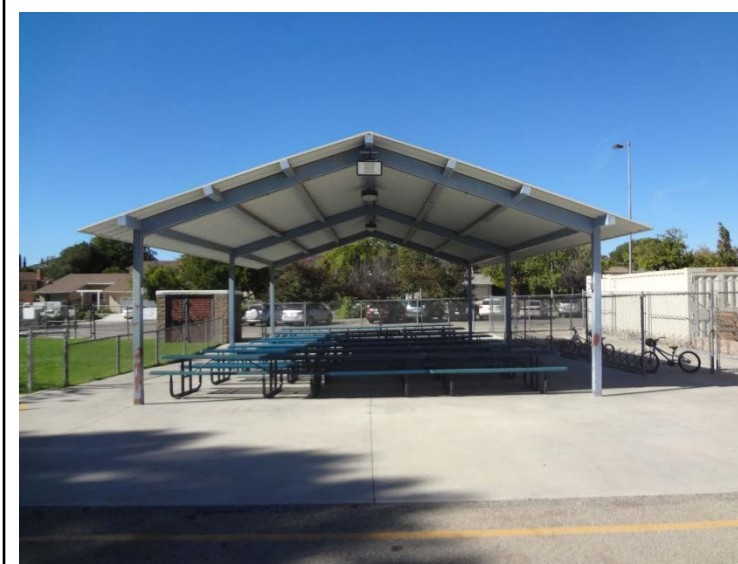
**Photo -3**  
**Curb Appeal – View of Lunch Shelter**  
 Large relatively new lunch shelter provides good protection from the elements during meal and break periods.

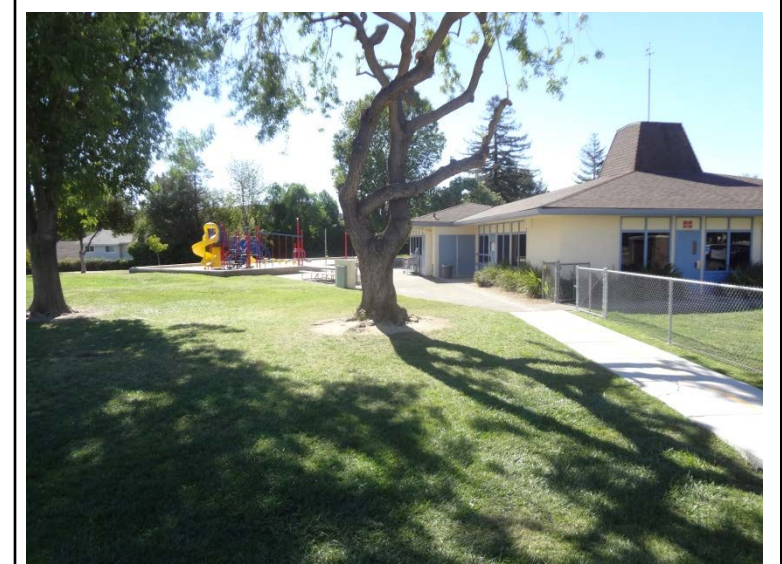
**Photo -4**  
**Curb Appeal – View of Kindergarten**  
 Kindergarten building is a separate structure in a separate portion of the campus. It is surrounded by large mature trees and landscaping.

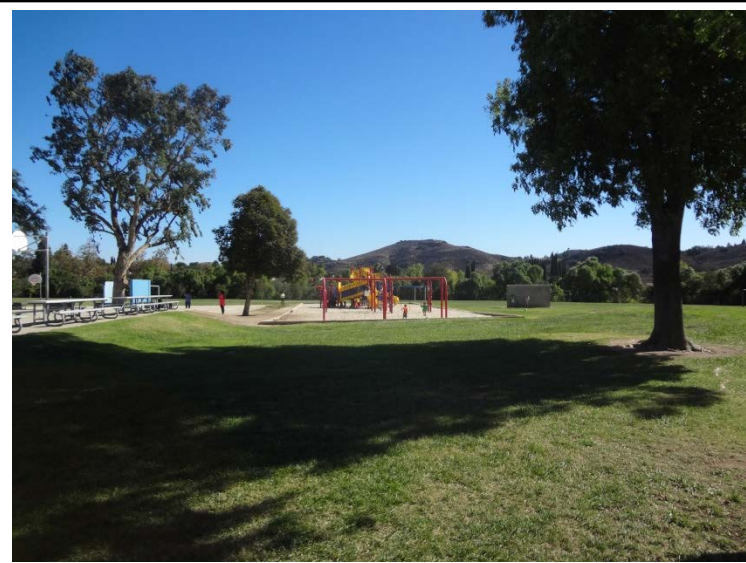
**Photo -5**  
**Curb Appeal – View of Playground**  
 The playground is large with mature trees and views of the mountains. The play equipment is surrounded by scenic views on all sides

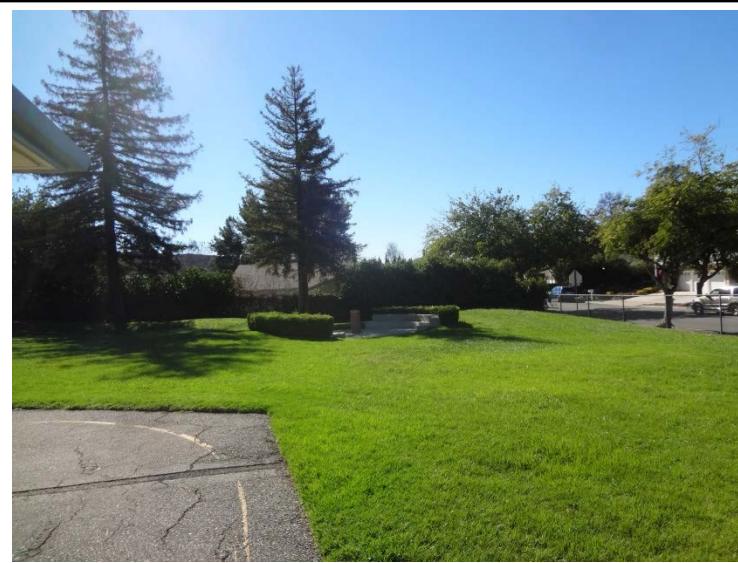
**Photo -6**  
**Curb Appeal – Outdoor Sitting Area**  
 An outdoor sitting area dedicated by one of the previous principals creates a rather intimate outdoor activity space for students.

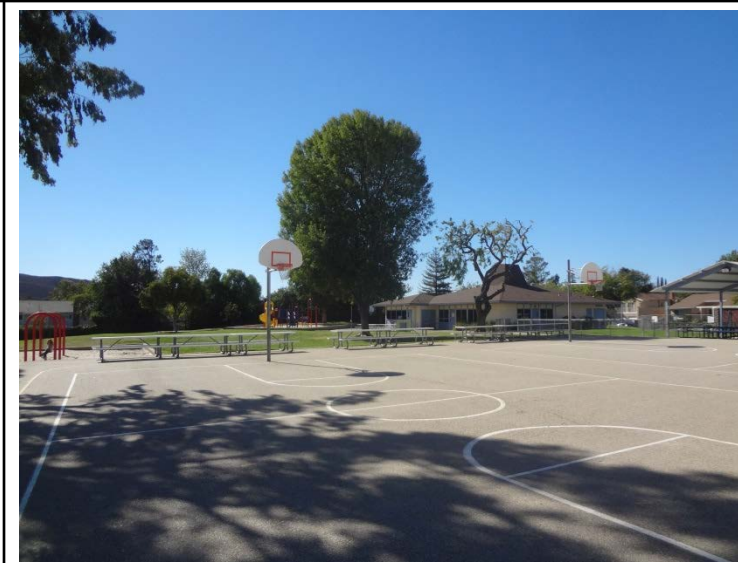
**Photo -7**  
**Curb Appeal – View of Playground**  
 The playground is large with mature trees and views of the mountains. The play equipment is surrounded by scenic views on all sides

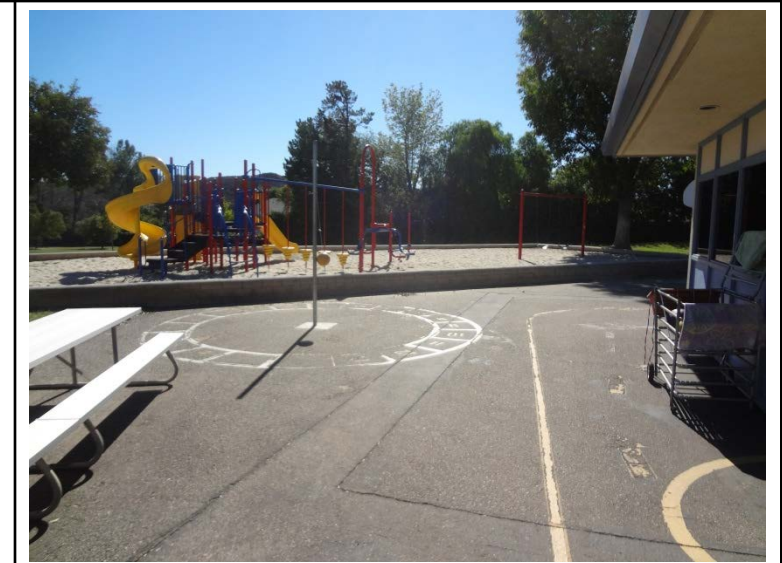
**Photo -8**  
**Curb Appeal – Kindergarten Play Area**  
 Kindergarten play area is efficiently laid out next to the kindergarten building.
